Client Name: Pritha Mahata
Client Address: 9 Kirkloch Close, WALLSEND NSW 2287
Our Reference: NSW25-00196

Construction - Framework

Property: Lot 3137 #17 Turnock Drive, CAMERON PARK NSW 2285
Inspection Date: 26/3/2025
Inspector: Greg Allen, Builders Licence 229366C

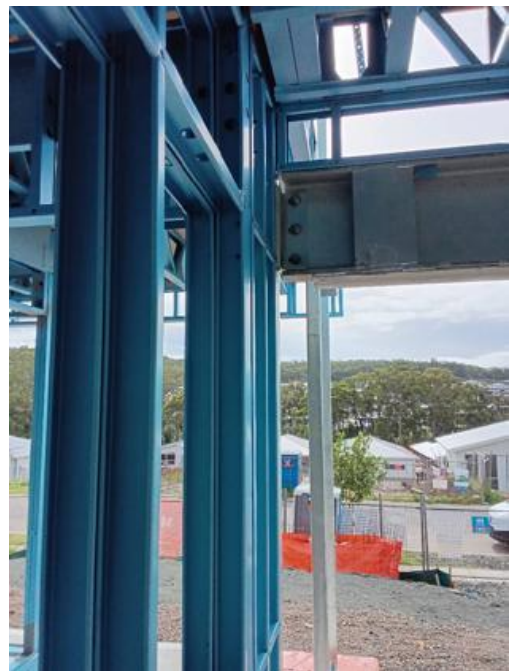
- Right-hand side garage / entry wall is out of alignment.
- Kitchen / pantry walls require further plumbing.
- Lounge / laundry wall out of line.
- Handrail section of the stairwell requires further plumbing.
- Study wall requires further straightening.
- Bedroom 2 window sill is out of level.
- Bedroom 4 wall requires further straightening.

Right-hand side garage wall

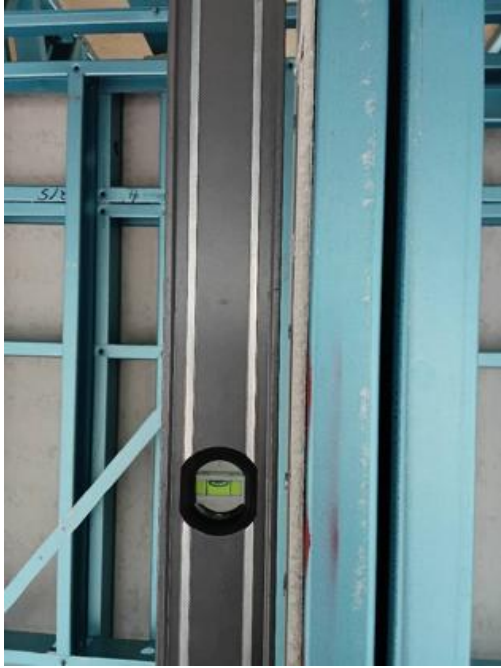
Kitchen / pantry walls require further plumbing

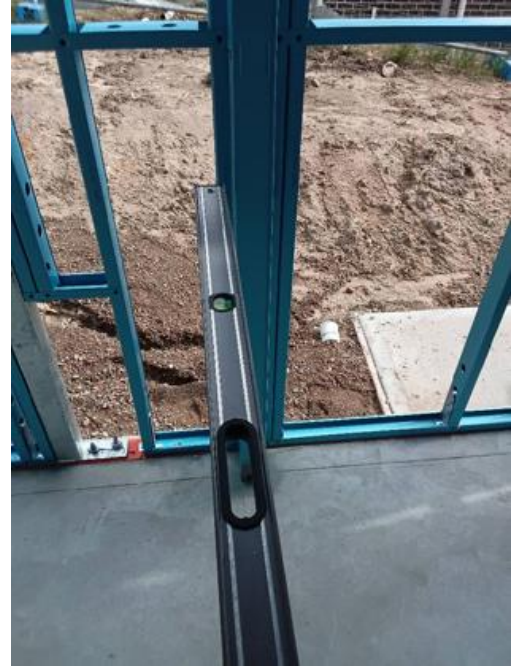
Lounge / laundry wall out of line

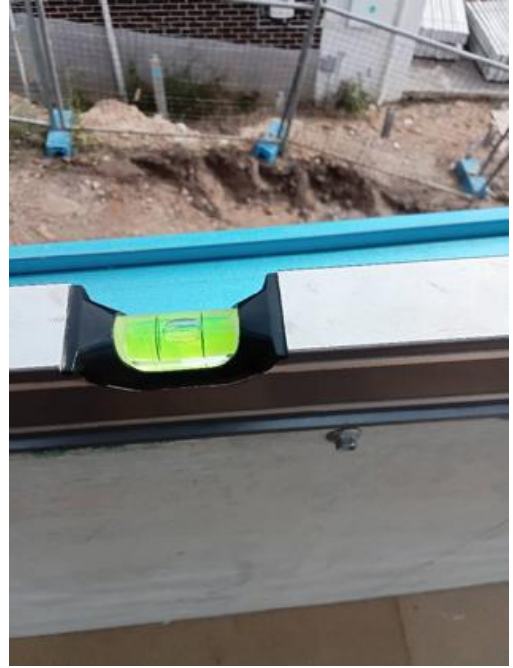
Bedroom 2 window sill

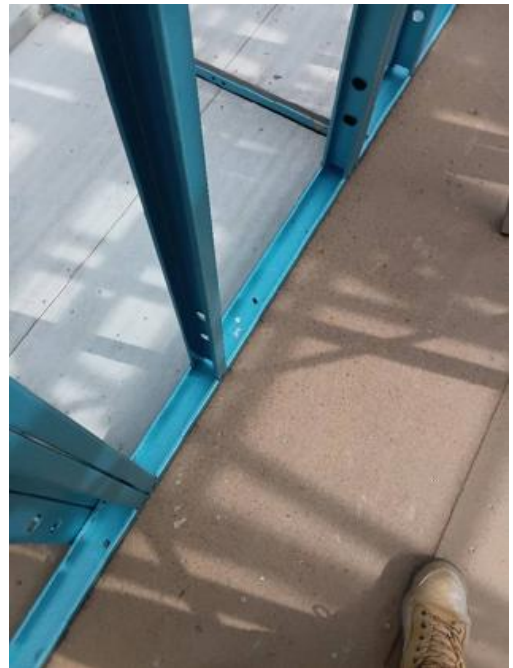
Frame of the bathroom is not fixed adequately.

Bathroom wall fixing

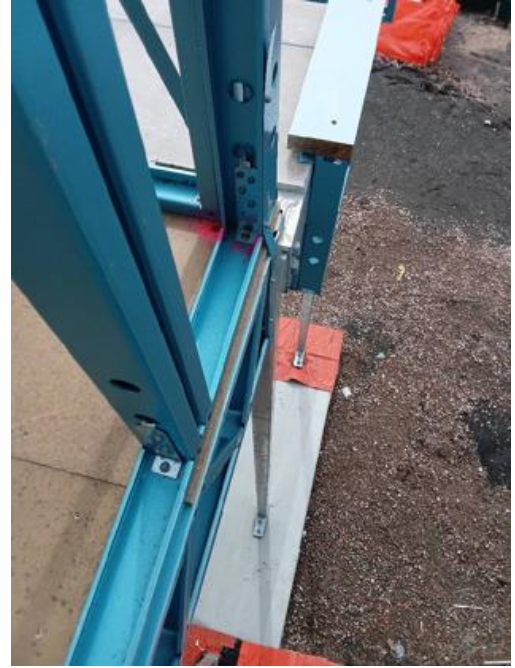
Frame of bedroom 2 sits back from the frame below, this should be checked when access is safe to do so.

Bedroom 2 / balcony junction

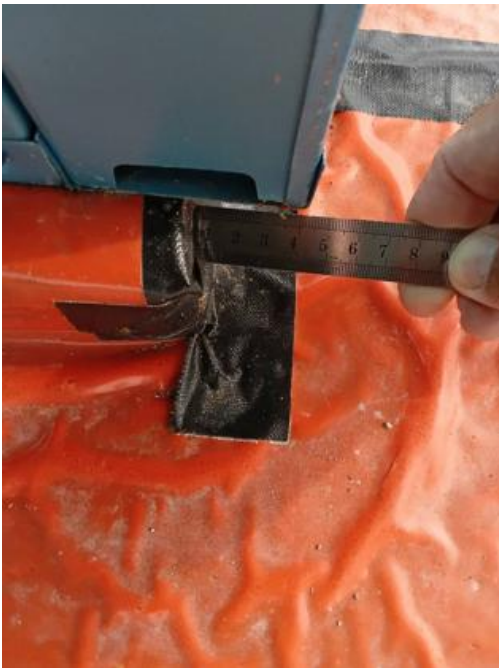
Frame overhang front

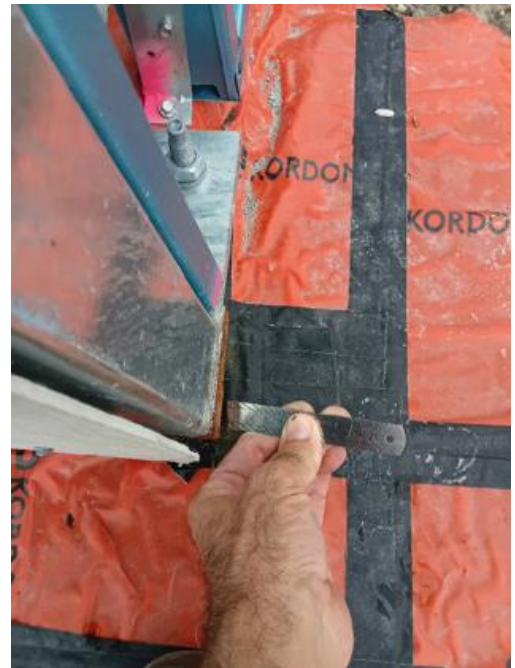
Frame overhang right-hand side

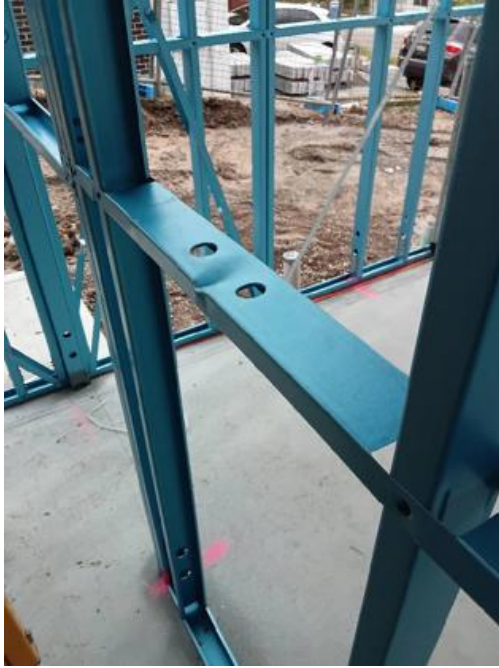
Damaged noggin study

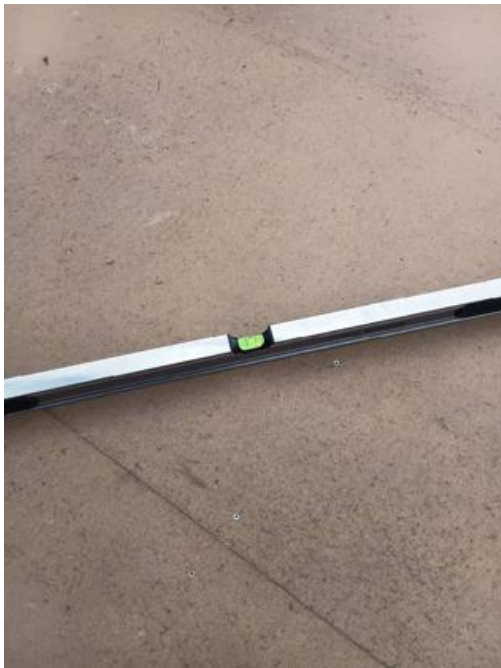
- Flooring to bedroom 1 is out of level.
- Defective overhangs noted in framing.

Bedroom 1 floor out of level

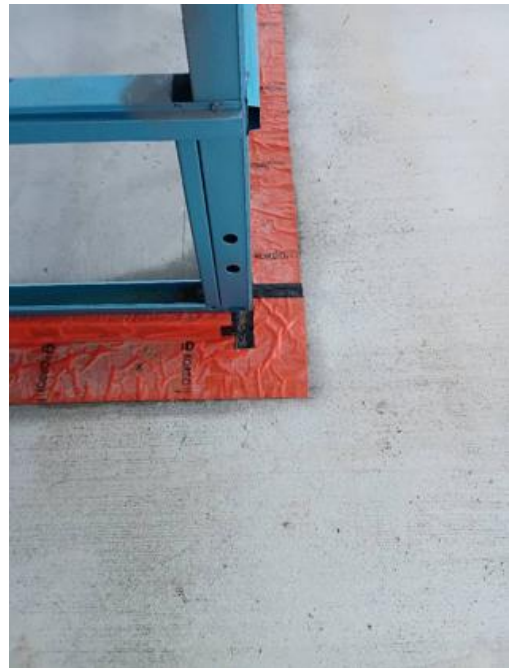
Defective overhangs noted in framing

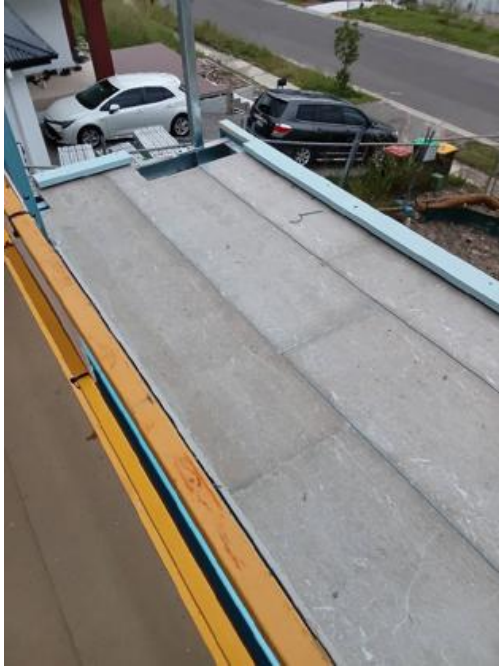
- Balcony could not be accessed due to safety reasons.

No access to balcony

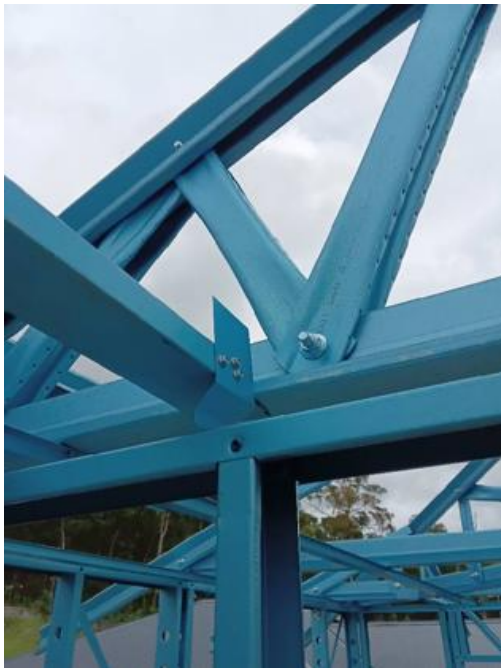
- Spacing to the internal wall braces should be checked on the first floor.
- Battens are not yet installed.

Internal wall bracing

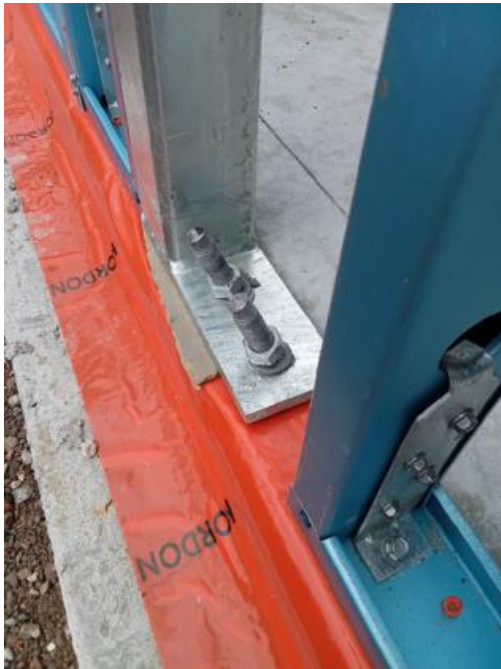
Fixing bolts fixed on an angle

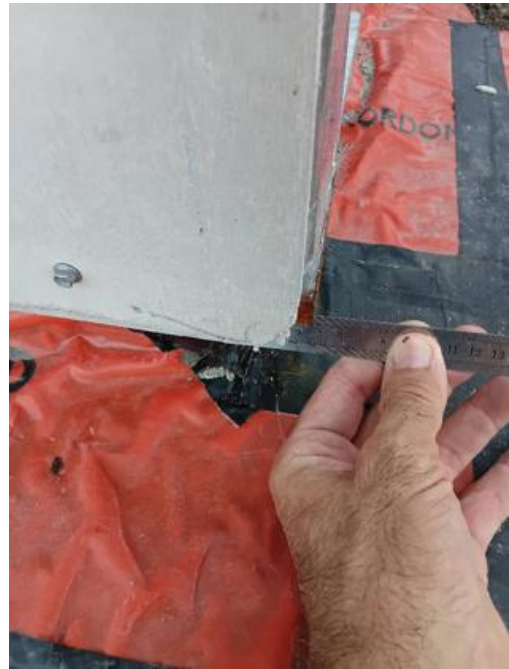
Defective overhang

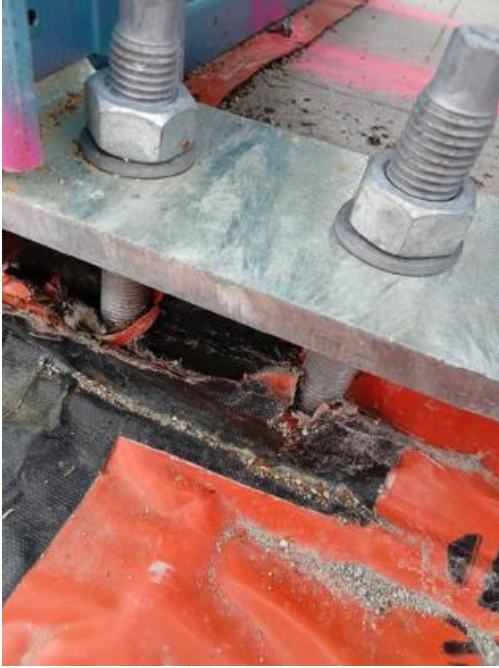
Termite barrier damaged

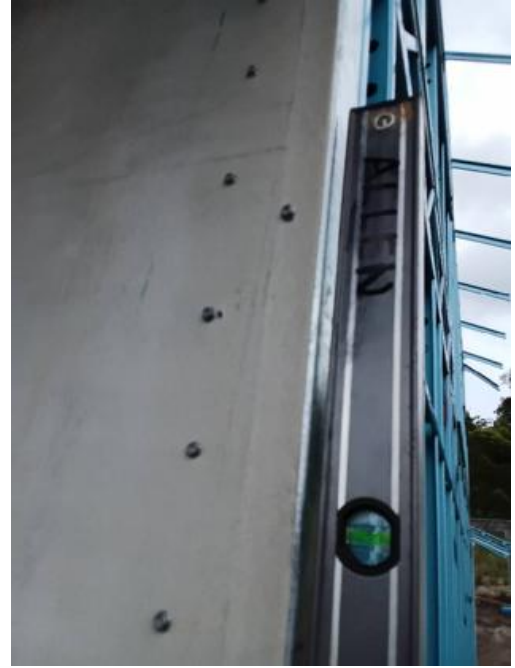
Column out of plumb front right-hand side

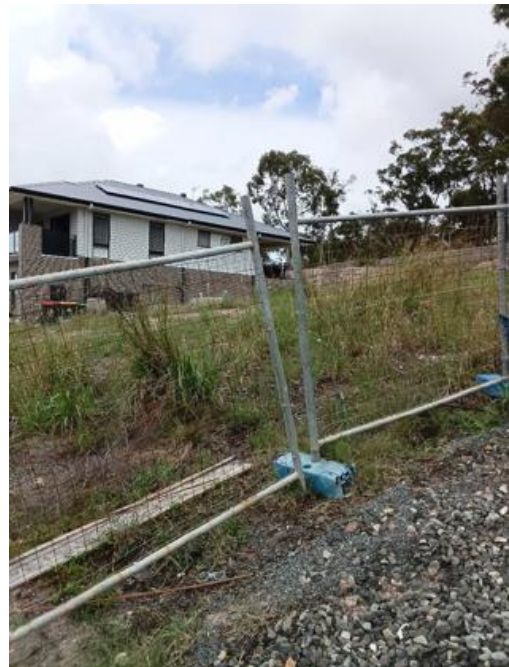
- The site fencing was not secure.

Gap in the fencing

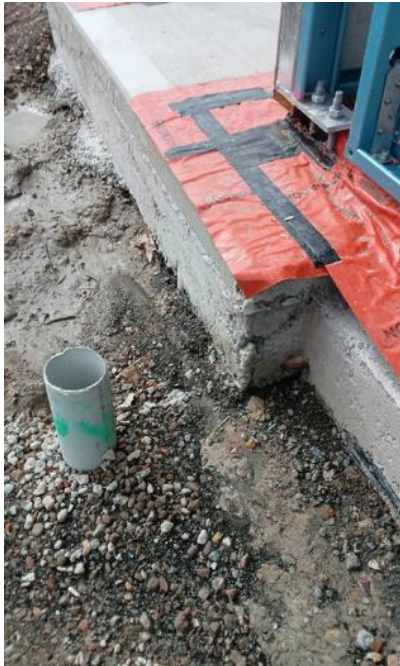
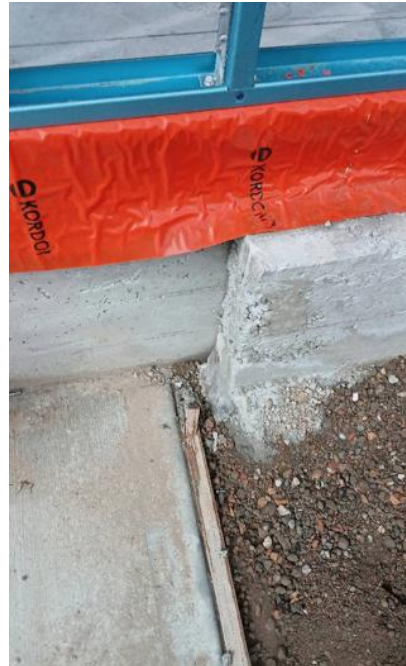
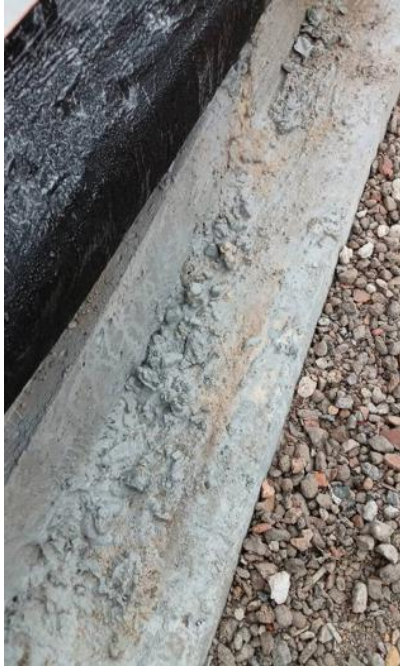
- Previous Inspection
- - No repairs to the concrete have taken place as yet.
- - There are several defects noted in the report which need repair before being covered up.
- - Satisfactory rectification proof including an engineer's detail where required (see frame & steel overhangs) should be supplied to the client.
- Due to the nature of the defects noted in this report, we not only recommend pursuing items as listed with your site supervisor/manager, but we also recommend a follow-up inspection be considered / scheduled to confirm rectification has been carried out to the defect items.

No concrete repair
