Client Name: Pritha Mahata
Client Address: 9 Kirkloch Close, WALLSEND NSW 2287
Our Reference: NSW25-00196

Construction - Framework

Property: Lot 3137 #17 Turnock Drive, CAMERON PARK NSW 2285
Inspection Date: 26/3/2025
Inspector: Greg Allen, Builders Licence 229366C

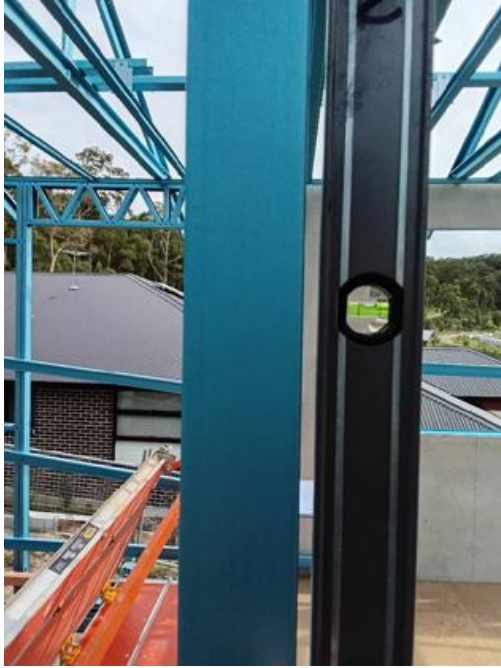
Bedroom 2 wall

Frame of bedroom 2 sits back from the frame below, this should be checked when access is safe to do so.

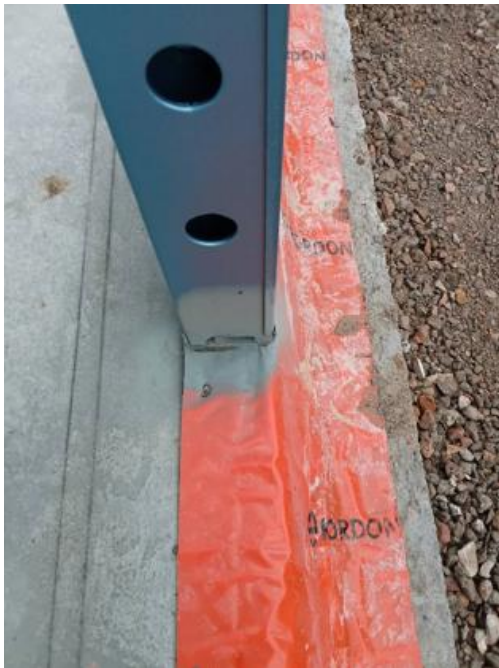
- There are multiple points where the frame is overhanging the slab, particularly at the front & right-hand side. An engineer's detail should be sought for rectification of these points.
- Damaged noggin study.
- Windows and doors have not yet been installed so no flashings are in place.
- Noted, the termite barrier to the external doors has been cut when the frame have been cut. The warranty of the termite barrier may have been breached so the installer should be consulted to verify warranty.
- Noted the fixing used for the bottom plate has blown the concrete in places.

Termite barrier
